Master of science in Mechanical Engineering

Standard vs. revolutionary sealing:

An investigative thesis on two methods of conceptual designing with regards to the root causes of failure mode in raw mill 7.

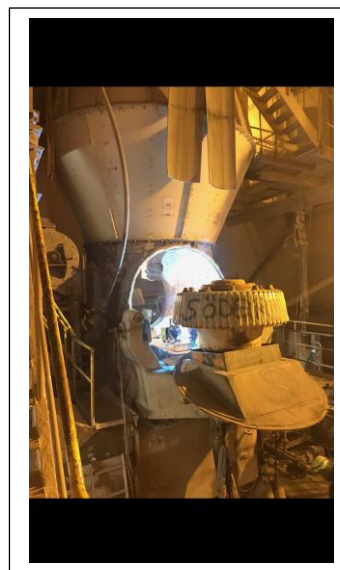
Figure 8. Grinding roller holder (folded out).

The rollers also spin around their own axis, and the material is ground in a material bed between the grinding track and rollers. The purpose of the gap is to eliminate metal on metal friction. Once ground, the material is once again subjected to the centrifugal force of the milling table and is driven further outwards toward the surrounding gas entries shown at the edge of the milling table in figure 4. Hot gas from the rotary furnace, as well as the cyclone system, is driven upwards through the entries around the milling table. This creates sort of a hurricane-like environment inside the raw mill. The stream of gas carries the ground material into a wind-sifter, also called classifier or separator shown in figures 9 and 10, where sufficiently ground fine flour passes through onto the next step of the process while not completely ground material is rejected. This material then falls into a return cone and afterward onto the milling table once again.

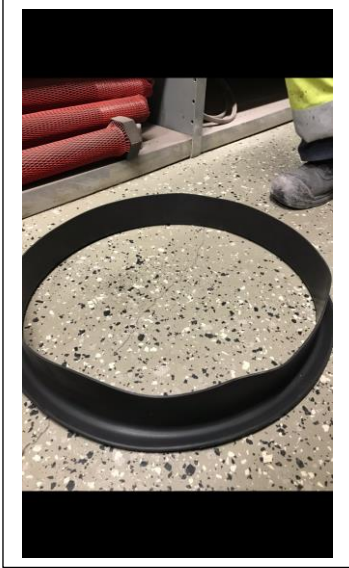
Figure 19. Rubber lip seal

What allows the cylindrical grinding rollers in raw mill 7 to rotate freely in a given direction around their axis are the bearings within. These bearings are periodically lubricated sufficiently enough to allow for efficient rotation. To protect the bearings and the lubricant inside from invasive material, seals are put in place. The primary seal is a lip seal made of elastomeric rubber, as shown in figure 19.

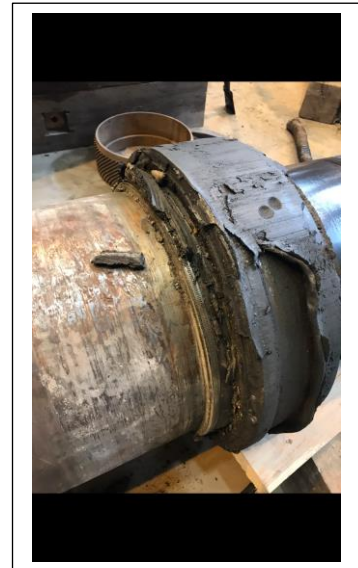
Figure 20. Visible wear on sealing components.

The fundamental problem is that the chosen rubber lip seal deteriorates at a high rate. A big factor to this would have to be the fact that the lip seal operates in dry conditions for the majority of the running time. There exists little to no lubrication film between the rubber and outer sealing ring it is in contact with during rotation. When newly mounted, the grinding roller is packed with lubricating grease, as shown in appendix 2. Grease is then periodically and manually pumped through the shaft up into the bearing and out through the sealing mechanism. This creates a sort of positive pressure of lubrication that is meant to keep invasive material from entering. With this in mind, the lubricant does reach the space between the rubber seal and outer sealing ring due to the positive pressure. However, the high operating temperatures quickly dry out the immediate lubrication film, and the constant blowing of raw material hardens the lubricant to the point of almost a solid-state, and dry friction between the components occurs instead. This can visibly be seen in figure 18. Also, the wear on the lip seal is visible in figure 20.

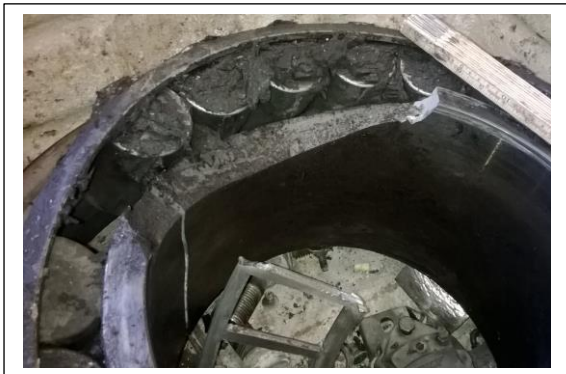
Figure 22. bearing failure (cracking).

Bearing failure can look something like, as shown in figures 22 and 23.

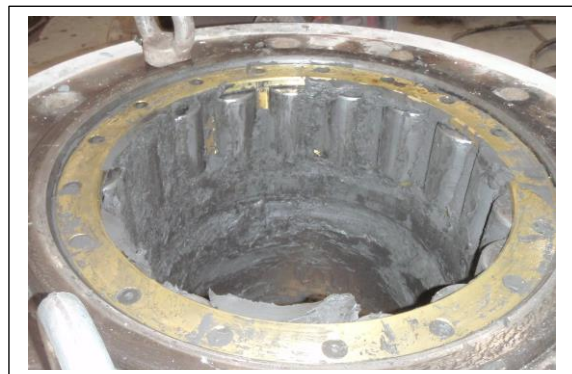
Figure 23. Bearing failure (clogging).

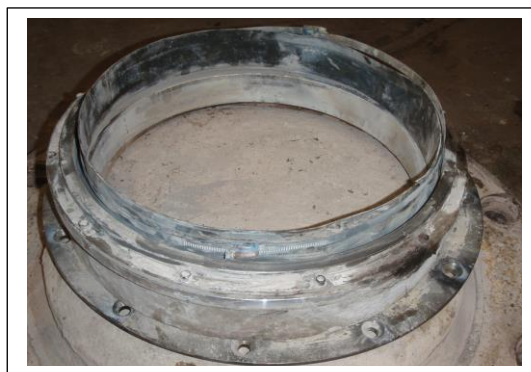
Figure 25. Deteriorated lip seal of raw mill 7th grinding roller.

Among other already mentioned factors to seal deterioration in raw mill 7 are grease hardening and raw material invasion. Figure 25 shows the worn lip seal of raw mill 7th grinding roller when disassembled.

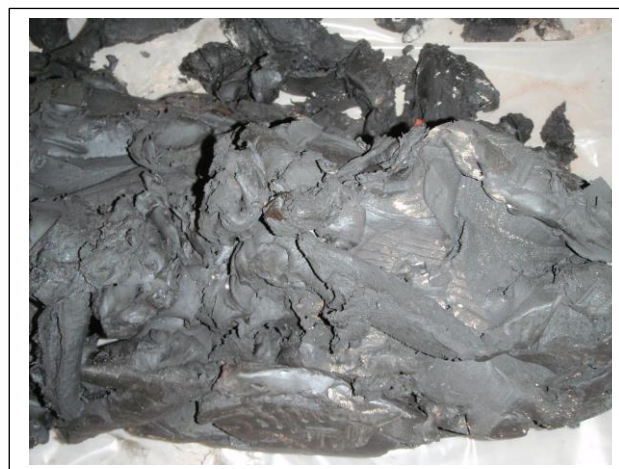
Figure 31. The state of the grease lubricant at failure mode.

Figure 31 shows the state of the grease inside the grinding roller bearings of raw mill 7 when disassembled after failure mode.

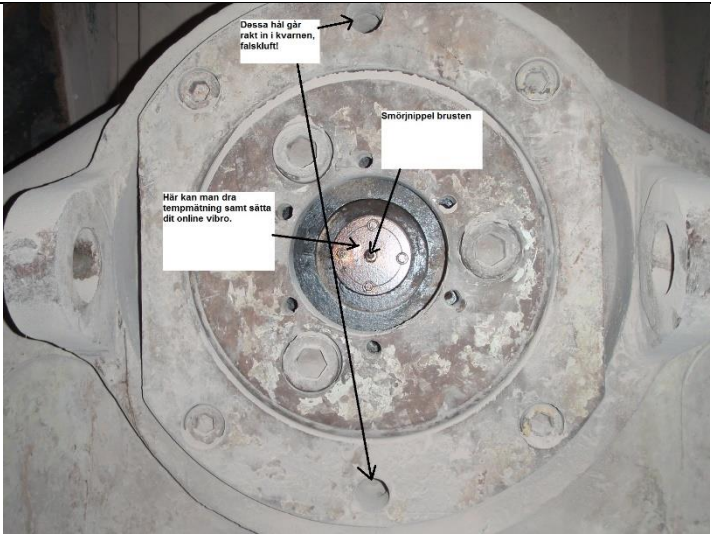
<p>Bild 2 visar hål där fett fanns i hålet, är detta utrett till 100 %? Finns det möjlighet att råmjöl kommer in till lager någonstans? Tätningar var enligt Lasse Hansson ok. Lager och tätningssätena ej ok, repigt och slitet. Troligen fett som tryckts in vid montering för att skydda gängor?</p>

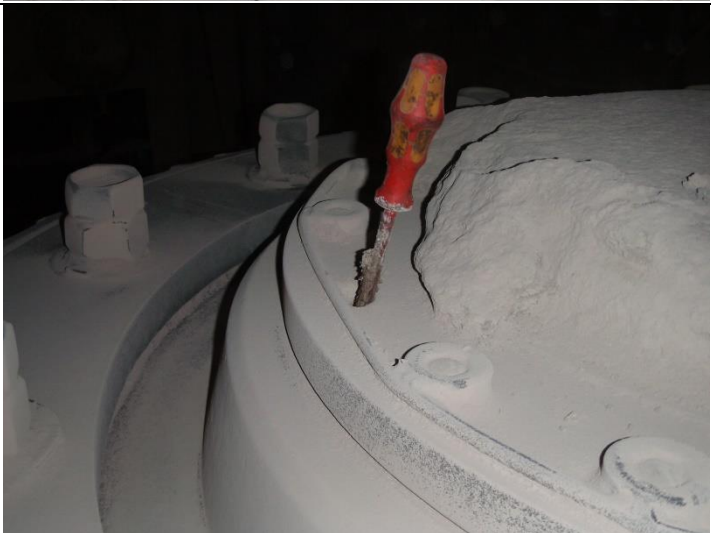
Bild 3 visar slam som bakar på är väldigt hårt, valsarna går i tuff miljö, med turbulens, undertryck, damm, vattenånga, hög belastning och hög temperatur.

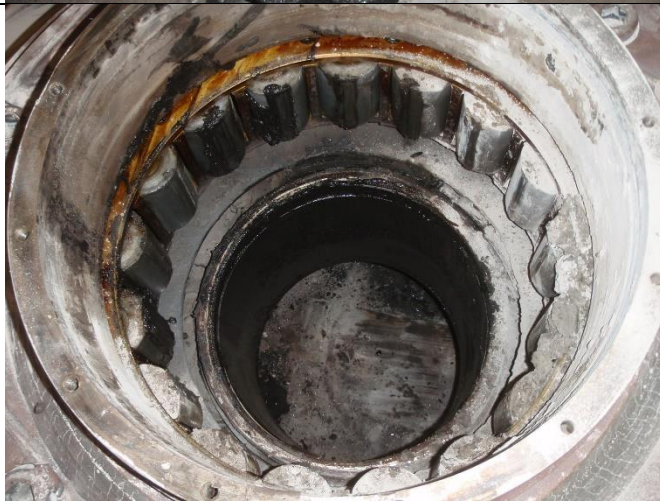
Bild 6
Alla lagerdelar tyder på
varmgång
