DAMAGE MONITORING OF SHIP FRP DURING EXPOSURE TO EXPLOSION IMPACTS

Sara Andersson¹, Kristian Haller², Sven-Erik Hellbratt³, Claes Hedberg^{1*}

Keywords: *damage monitoring, impact response, nonlinear acoustics*

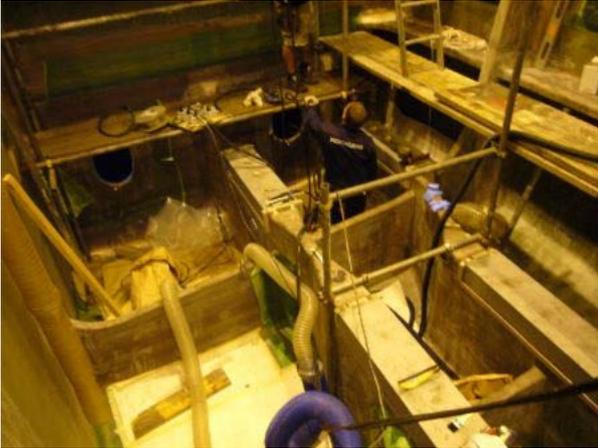
Figure 2. The ship full scale test section during its construction at Kockums, Karlskrona. The PZT ship hull sensors were later placed where the white plate on the bottom and on the vertical sides where the plastic tubes are, see Figure 5.

A ship section made by Glass Fiber Reinforced Plastics was especially manufactured for this test at the Kockums ship yard in Karlskrona, Sweden, see Figure 2. It has the dimension 12*10*6.5 meters, and contained a few parts of steel machinery necessary to imitate a real vessel's local inertia.

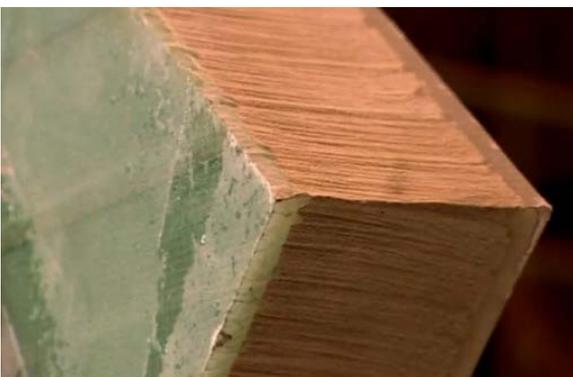
Figure 3. A cut of the Fiber Reinforced Plastics manufactured by Kockums and DIAB.

The core material is Divinycell, a polymer foam which is produced by DIAB through a vacuum assisted infusion technique [8].

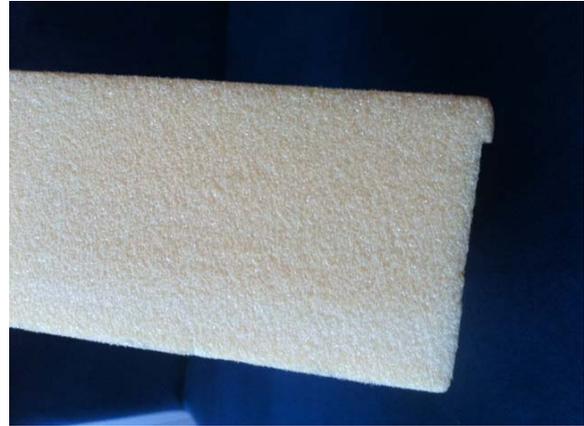
Figure 4. Another sample of a the Divinycell core material from DIAB.

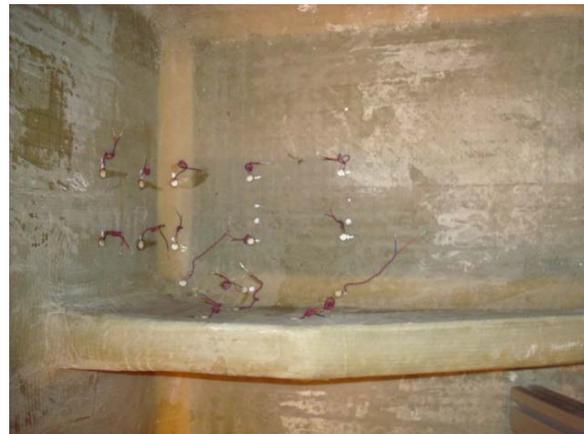
Figure 5. The PZT sensors were placed in regions where damage was expected.

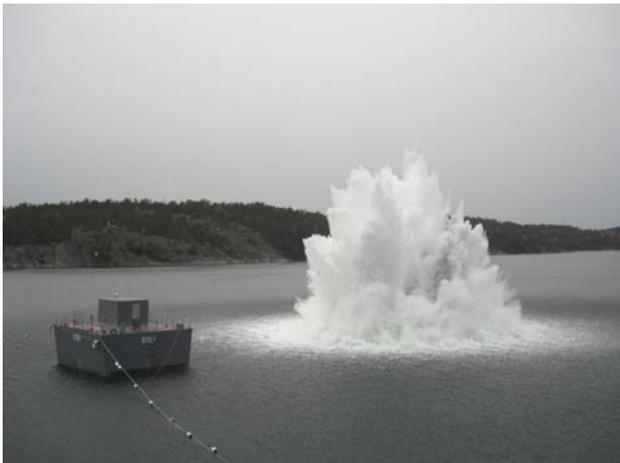
Figure 6. Explosives were detonated underwater some distance from the test section.

The blasts were increasing in impact level successively. The sensors were during the blasts left on the ship hull, while the rest of the equipment could not be left on the ship because of the high risk for damage. This meant that in between the blasts there was a time scope within which the equipment had to be transported to the ship and set up. Then the measurements were made and the equipment had to be brought back to land again.
